**COMMITTEE OF THE WHOLE COUNCIL MEETING**  
**August 9, 2022**

MUNICIPALITY OF THE DISTRICT OF BARRINGTON  
INFRASTRUCTURE ASSESSMENT AND RECOMMENDATIONS

**MUNICIPALITY OF THE DISTRICT OF BARRINGTON  
RECREATION CENTRE ASSESSMENT**

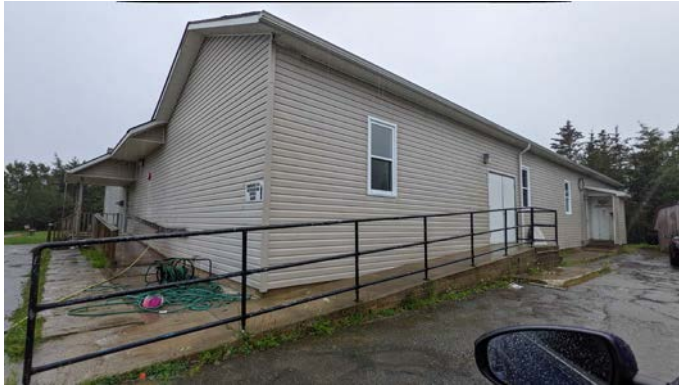
**Photo 1: Northeast Corner of the Building**

The existing access ramp does not meet current codes for accessibility. Safety concerns include the horizontal guardrail bars opening dimensions between structural components, lack of required flat areas at top and bottom, clearance at exterior door swings, and lack of handrail extension.

Additional maintenance and potential concerns for water ingress include the lack of a rain gutter on the side shed roof, and the single rainwater leader at centre of elevation adjacent double door.

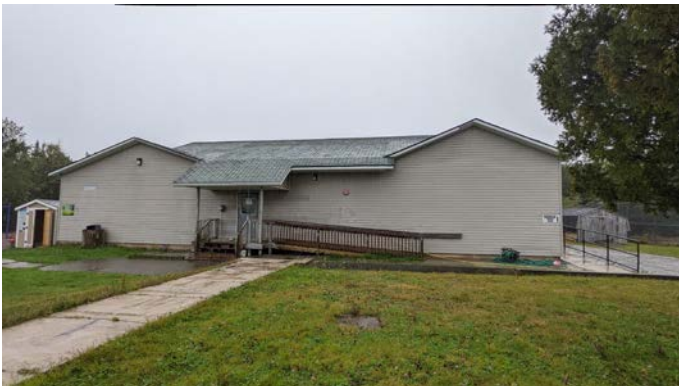
**Photo 2: East Elevation (Front Entrance)**

Missing rain gutter and rainwater leaders at main entrance roof above access stair and ramp result in safety concerns for slippery surfaces. Lack of water control also contributes to building envelope damage and potential water ingress.

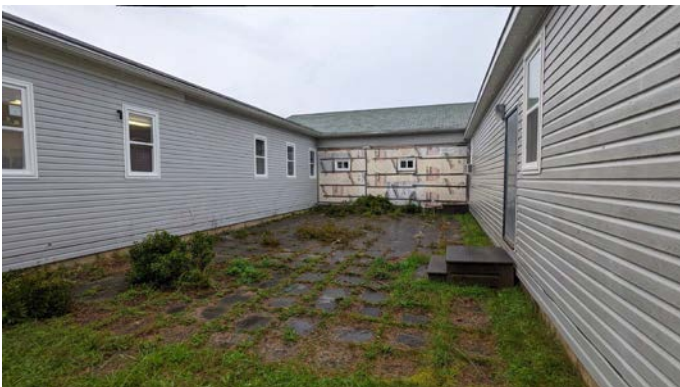
**Photo 3: West Elevation (Courtyard) – Wall Damage**

Photo shows the two re-purposed DND structures with connection area which create an exterior courtyard. Note the new window mounted air conditioner on right side. The connection area wall was observed to be “Soggy” with exposed, weathered air barrier. This does not provide a weather resistant cladding, allowing water infiltration to the interior. See also Photo 7 below.

Note that the exposed wall covers the washrooms and the mechanical/electrical room. Both of these areas are potentially wet based on their intended use.

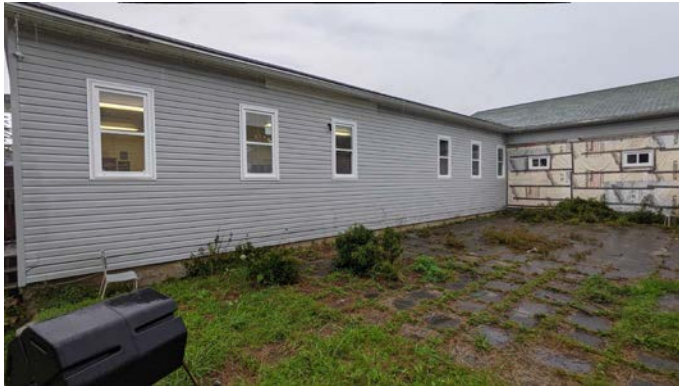
**Photo 4: West Elevation (Courtyard) – Roof Damage**

Roof shingles at ridgeline are missing/broken, potentially allowing water into the truss space below. This may also be contributing to the “Soggy” exterior wall below.

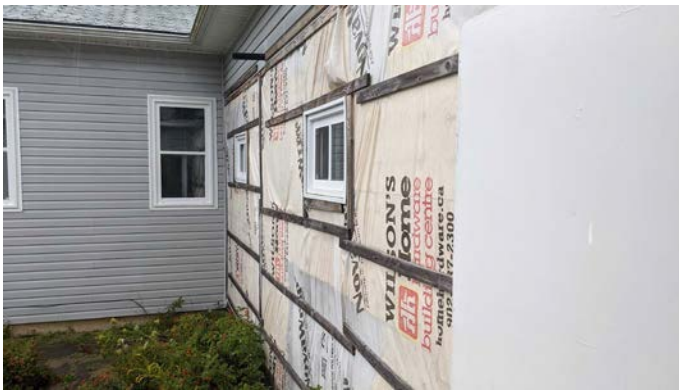
**Photo 5: West Elevation (Courtyard) – Wall Damage**

Weeds and bushes have grown since site visit in 2017. Lack of exterior maintenance may contribute to interior space water damage.

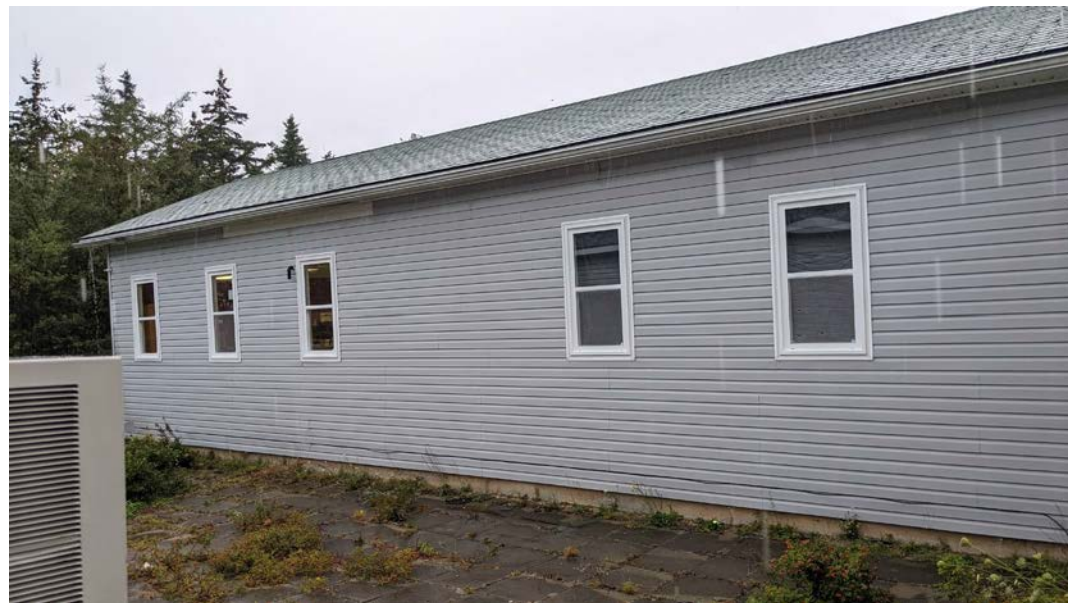
**Photo 6: North Elevation (Courtyard)**

This area presently houses the daycare facility. Note: roof condition deterioration compared to original 2017 assessment.

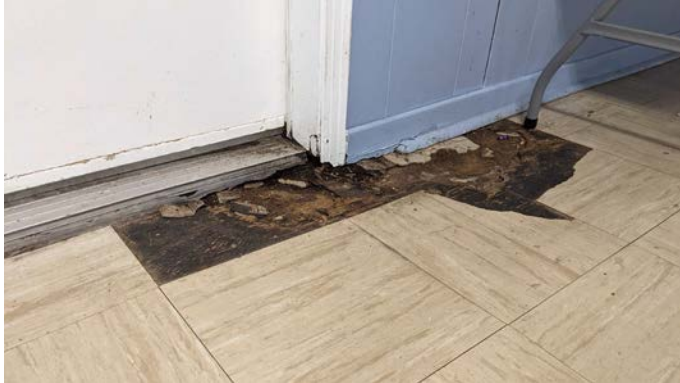
**Photo 7: Courtyard Door Water Infiltration**

On-going water infiltration at exit door has caused floor rot below broken vinyl floor tiles. Deteriorated floor structure is a safety concern. Additionally, broken floor tiles create a trip hazard at the exit door. See also Photo 3.

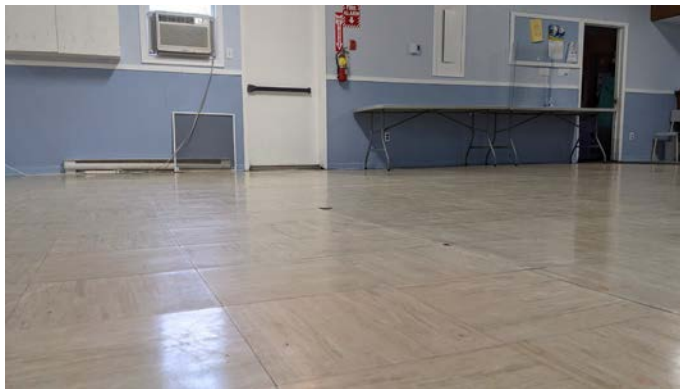
**Photo 8: Uneven Floor Indicating Floor Joist Damage**

Floor structure adjacent the exit door is not flat. Water infiltration from door area (above photo) may be contributing to additional damage. The uneven floor also is a safety & tripping hazard.

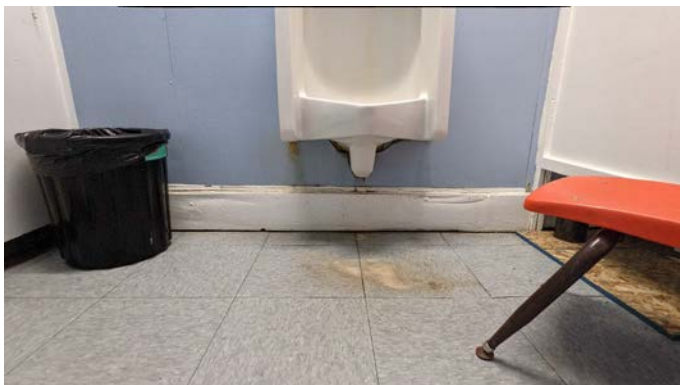
**Photo 9: Male Washroom Floor Damage**

Floor was damaged and recently patched at the adjacent toilet stall.

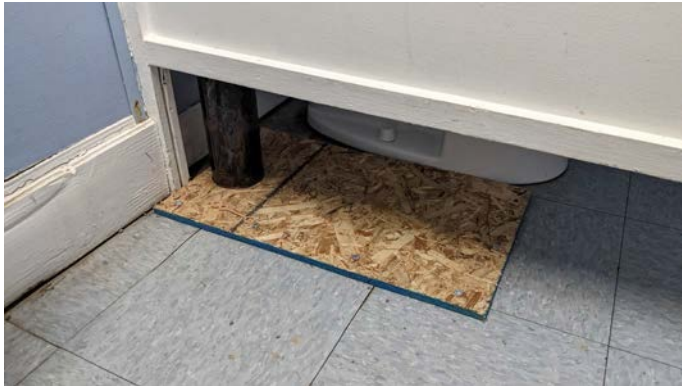
**Photo 10: Male Washroom Patch**

Patched area where reportedly a person put foot through floor. This is a safety concern likely the result of floor rot and deterioration caused by on-going water damage.

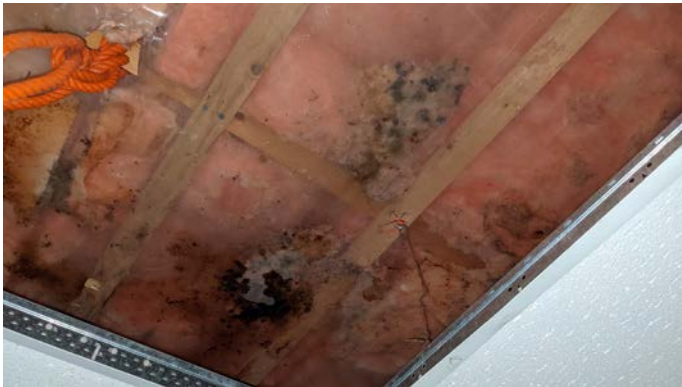
**Photo 11: Roof Damage in Attic Space**

Ceiling space above the music instruments storage area. Black spots may indicate mold growth. (Not tested)

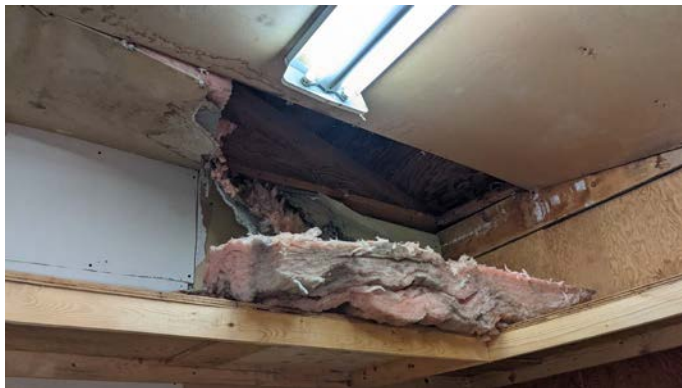
**Photo 12: Water Damage & Insulation**

Gypsum Board ceiling showing water damage and deteriorated insulation. No vapour barrier observed.

Water damage may be result of roof leaks or condensation.

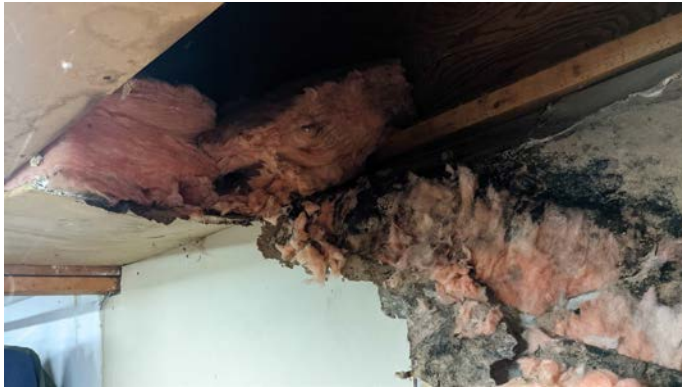
**Photo 13: Water Damage and Insulation from Above Ceiling.**

Deteriorated roof insulation which has come through water damaged gypsum board ceilings.

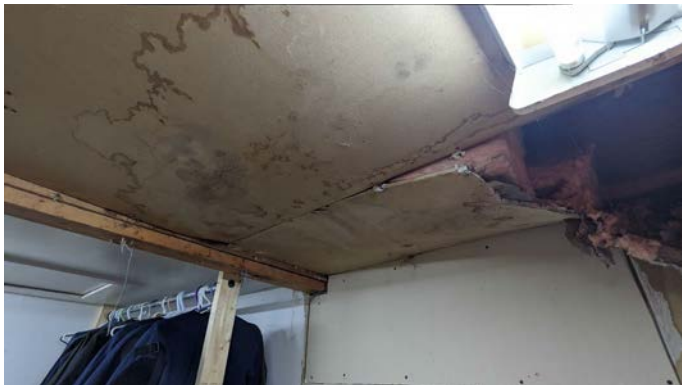
**Photo 14: Water & Ceiling Damage**

Ceiling of Cadet's storage area near front of building beside shed showing water damage from truss space above.

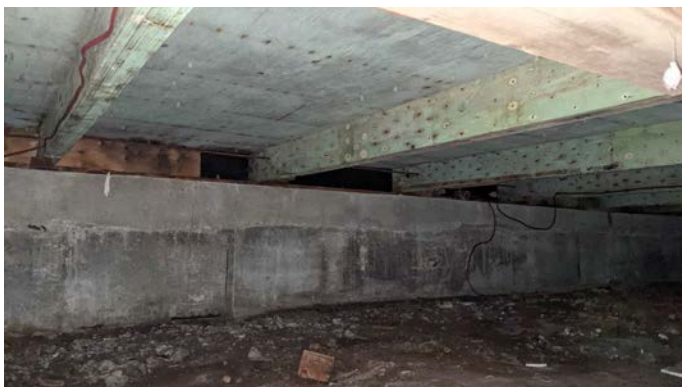
**Photo 15: Crawl Space Under Building**

Concrete support beams with timber joists appear to be dry and in good condition.

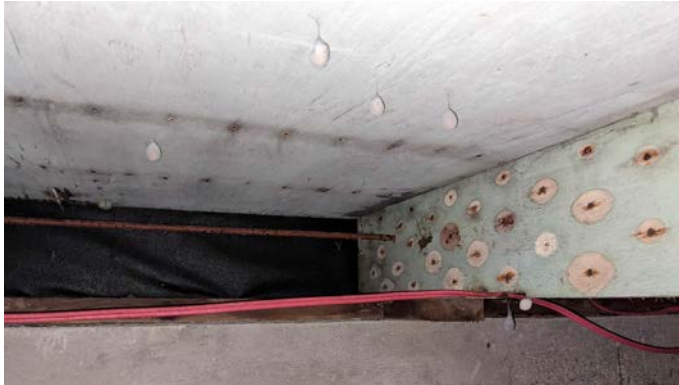
### Photo 16: Crawl Space under Building

Timber floor joists supporting the Recreation Centre floor above. Rust on nails for joists is not a concern.

Area is generally dry, supporting concern that water damage is coming from above.
