COMMITTEE OF THE WHOLE COUNCIL MEETING
August 9, 2022

MUNICIPALITY OF THE DISTRICT OF BARRINGTON INFRASTRUCTURE ASSESSMENT AND RECOMMENDATIONS

**MUNICIPALITY OF THE DISTRICT OF BARRINGTON
RECREATION CENTRE ASSESSMENT**

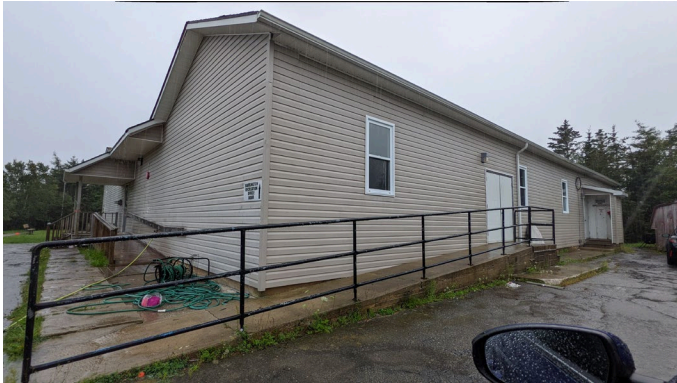
Photo 1: Northeast Corner of the Building

The existing access ramp does not meet current codes for accessibility. Safety concerns include the horizontal guardrail bars opening dimensions between structural components, lack of required flat areas at top and bottom, clearance at exterior door swings, and lack of handrail extension.

Additional maintenance and potential concerns for water ingress include the lack of a rain gutter on the side shed roof, and the single rainwater leader at centre of elevation adjacent double door.

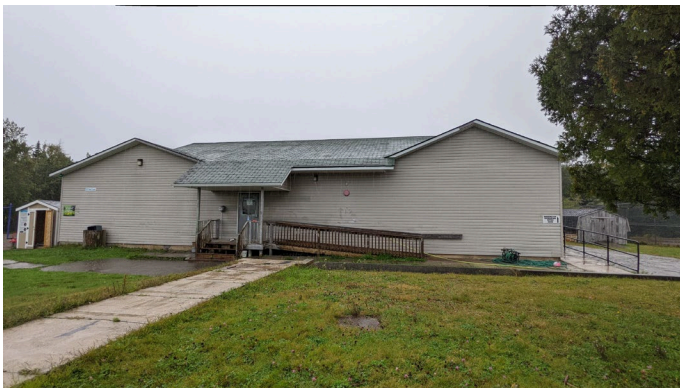
Photo 2: East Elevation (Front Entrance)

Missing rain gutter and rainwater leaders at main entrance roof above access stair and rap result in safety concerns for slippery surfaces. Lack of water control also contributes to building envelope damage and potential water ingress.

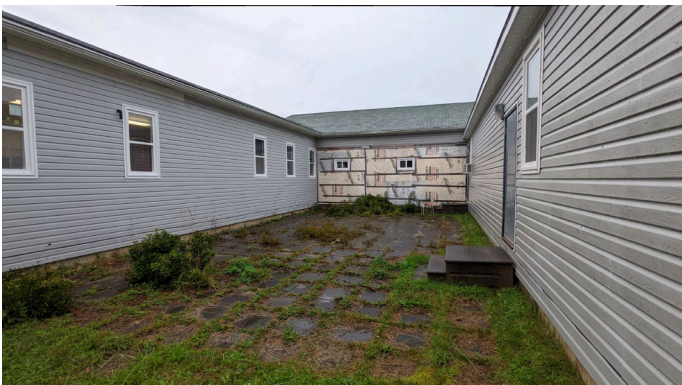
Photo 3: West Elevation (Courtyard) – Wall Damage

Photo shows the two re-purposed DND structures with connection area which create an exterior courtyard. Note the new window mounted air conditioner on right side. The connection area wall was observed to be “Soggy” with exposed, weathered air barrier. This does not provide a weather resistant cladding, allowing water infiltration to the interior. See also Photo 7 below.

Note that the exposed wall covers the washrooms and the mechanical/electrical room. Both of these areas are potentially wet based on their intended use.

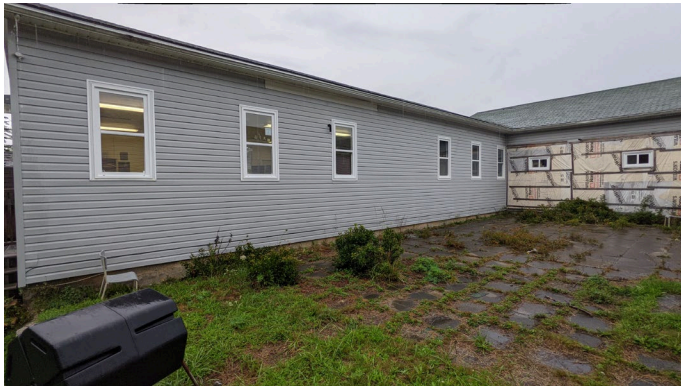
Photo 4: West Elevation (Courtyard) – Roof Damage

Roof shingles at ridge line are missing/broken, potentially allowing water into the truss space below. This may also be contributing to the “Soggy” exterior wall below.

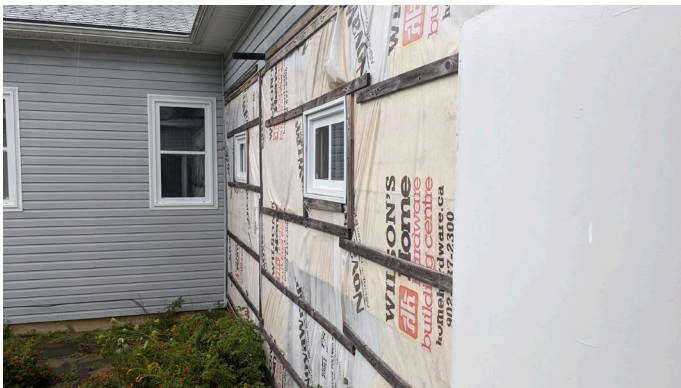
Photo 5: West Elevation (Courtyard) – Wall Damage

Weeds and bushes have grown since site visit in 2017. Lack of exterior maintenance may contribute to interior space water damage.

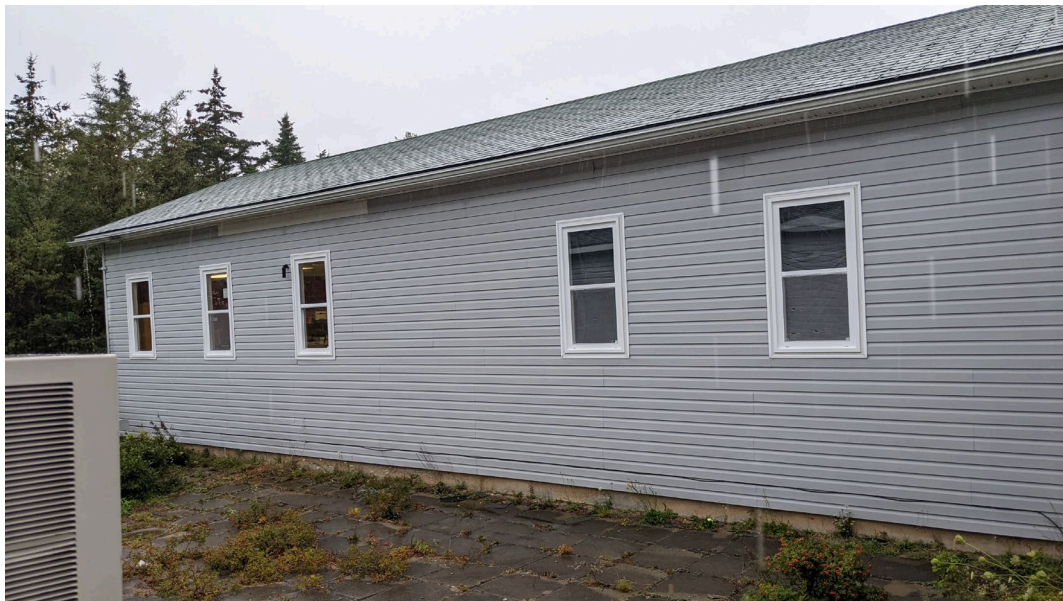
Photo 6: North Elevation (Courtyard)

This area presently houses the daycare facility. Note: roof condition deterioration compared to original 2017 assessment.

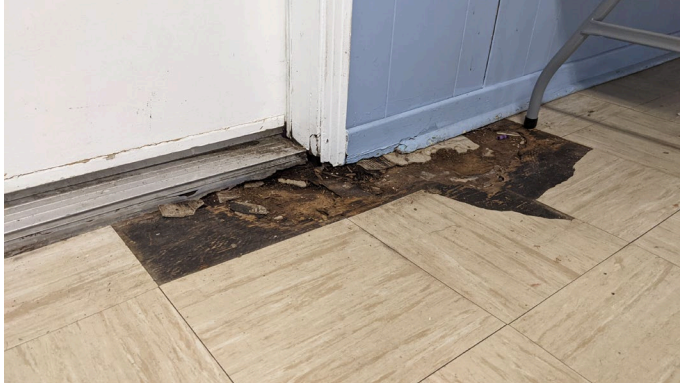
Photo 7: Courtyard Door Water Infiltration

On-going water infiltration at exit door has caused floor rot below broken vinyl floor tiles. Deteriorated floor structure is a safety concern. Additionally, broken floor tiles create a trip hazard at the exit door. See also Photo 3.

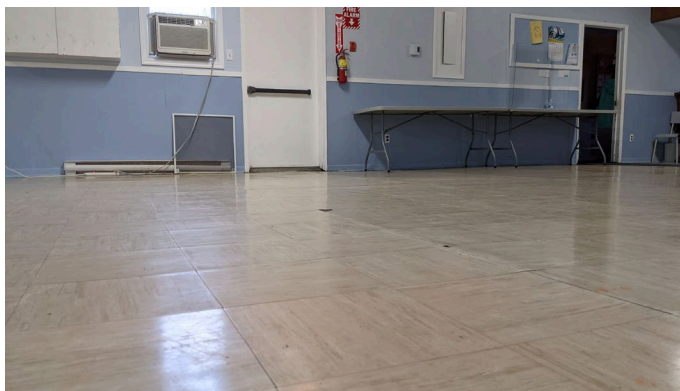
Photo 8: Uneven Floor Indicating Floor Joist Damage

Floor structure adjacent the exit door is not flat. Water infiltration from door area (above photo) may be contributing to additional damage. The uneven floor also is a safety & tripping hazard.

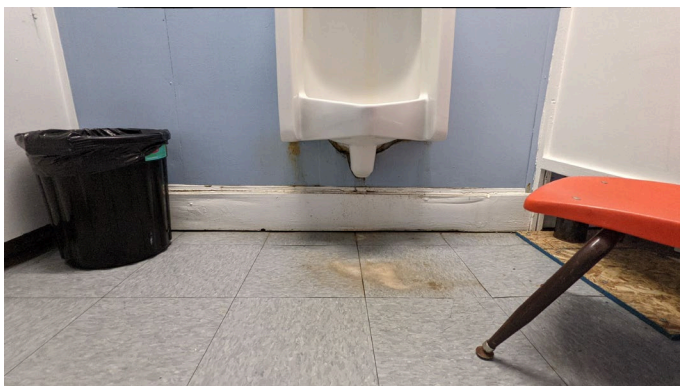
Photo 9: Male Washroom Floor Damage

Floor was damaged and recently patched at the adjacent toilet stall.

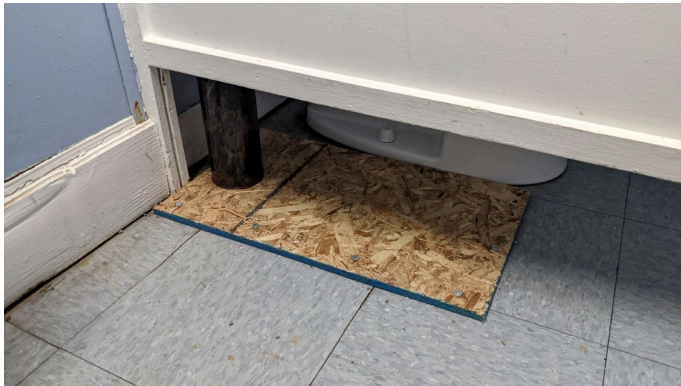
Photo 10: Male Washroom Patch

Patched area where reportedly a person put foot through floor. This is a safety concern likely the result of floor rot and deterioration caused by on-going water damage.

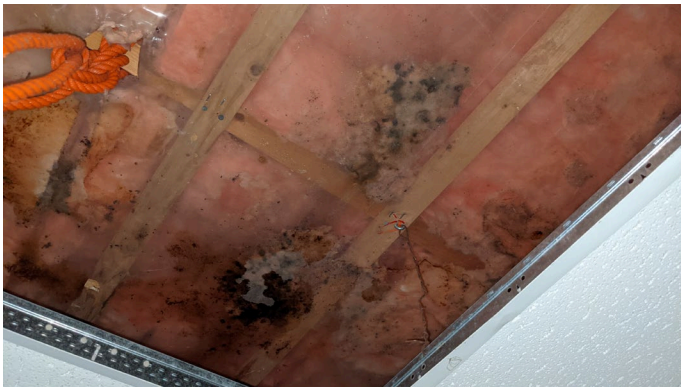
Photo 11: Roof Damage in Attic Space

Ceiling space above the music instruments storage area. Black spots may indicate mold growth. (Not tested)

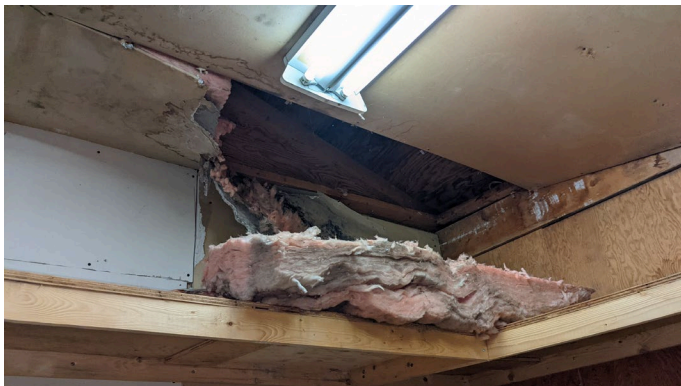
Photo 12: Water Damage & Insulation

Gypsum Board ceiling showing water damage and deteriorated insulation. No vapour barrier observed.

Water damage may be result of roof leaks or condensation.

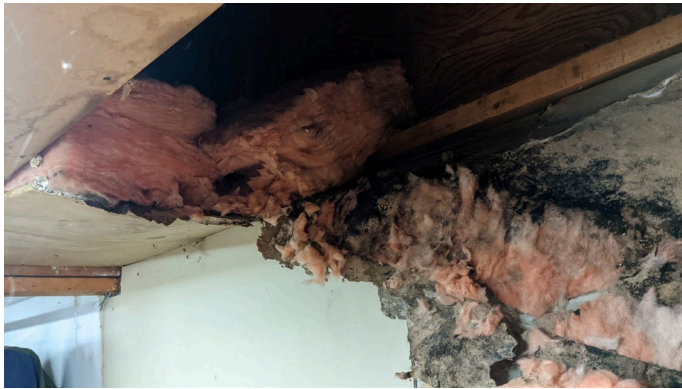
Photo 13: Water Damage and Insulation from Above Ceiling.

Deteriorated roof insulation which has come through water damaged gypsum board ceilings.

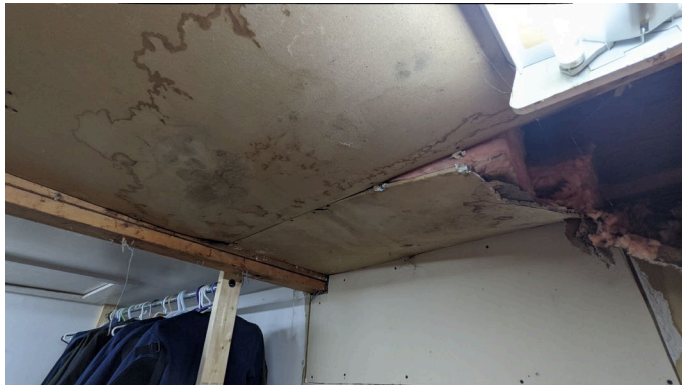
Photo 14: Water & Ceiling Damage

Ceiling of Cadet's storage area near front of building beside shed showing water damage from truss space above.

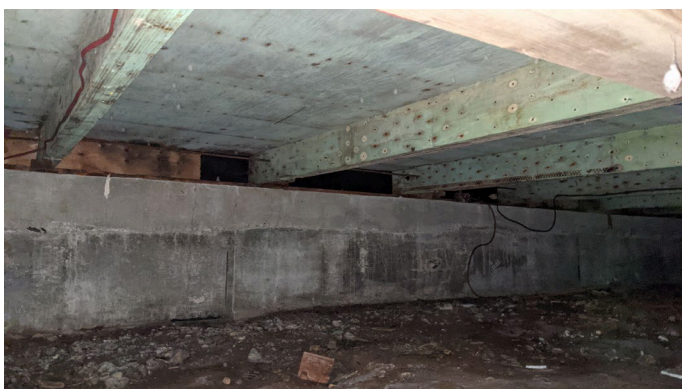
Photo 15: Crawl Space Under Building

Concrete support beams with timber joists appear to be dry and in good condition.

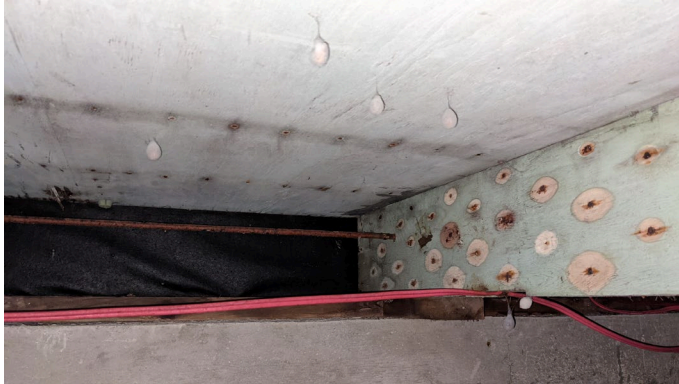
Photo 16: Crawl Space under Building

Timber floor joists supporting the Recreation Centre floor above. Rust on nails for joists is not a concern.

Area is generally dry, supporting concern that water damage is coming from above.
