MUNICIPALITY OF THE DISTRICT OF BARRINGTON

*Supply and Installation of Dehumidifier for
Curling Rink
(eg. Cimco Desicon ET)*

Barrington NS Arena and Curling Rink Humidity Study Final Report

160403.00 • Report • March 9, 2016

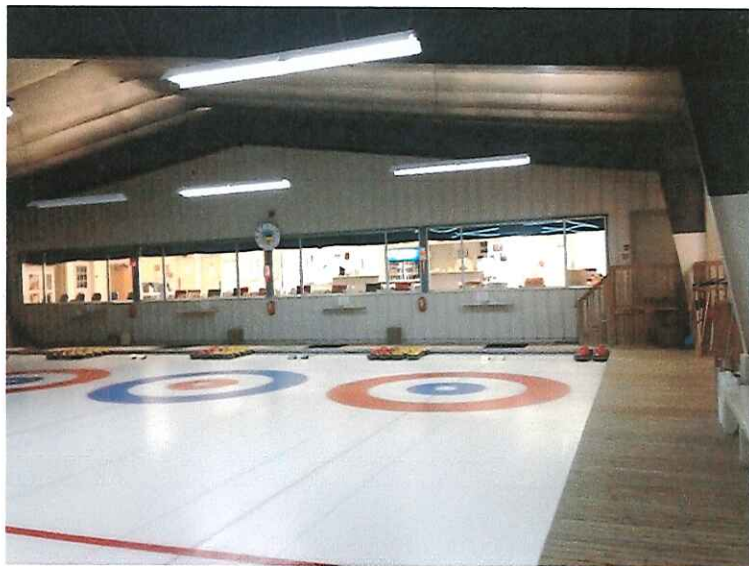
Figure 2-1: Curling Rink

The building is steel framed with a sloped steel framed roof. The exterior siding is metal and the walls are insulated with batt insulation. The insulation is covered on the interior face using a plastic material which also serves as vapour barrier. The roof is insulated in the same way as the walls. A reflective low-emissivity ceiling has been installed below the roof insulation. The building is built as a slab-on-grade with a concrete foundation that does not extend much above grade.

The rink has no exterior windows. The exterior doors consist of a single overhead door and several fire exit man doors. The doors are not used during the curling season and appear to be adequately sealed against unwanted infiltration of outdoor air. There are two doors that link the rink to the bar. They are typically kept closed as much as possible. These doors do not have vestibules.

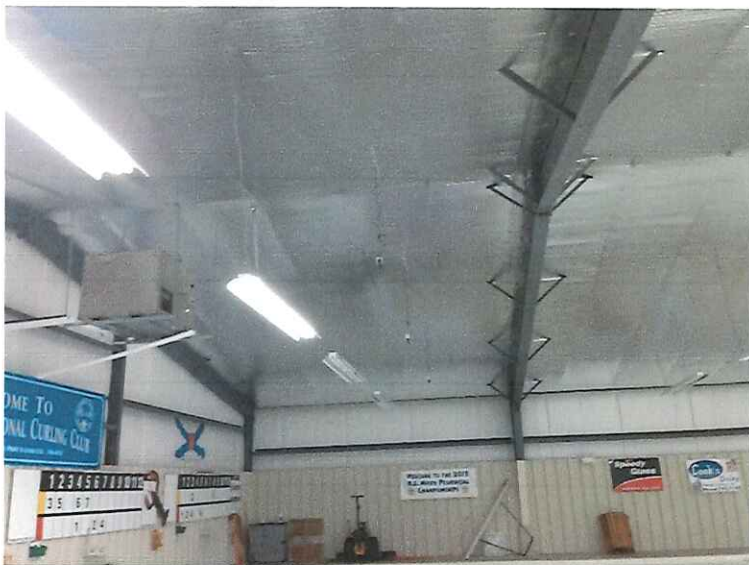
Figure 2-2: Structure

The metal structure extends through the insulation on both the walls and roof. This creates a thermal bridge conducting heat (and cold) to and

from the outside via the metal structure. When it is colder outside than in the rink, this creates a colder-than-ambient surface where water is more likely to condense. Rink staff report that condensation has been observed dripping from the structure.

Lights and cameras are suspended on metal chains and the chains are connected to the metal structure. The metal chain acts as a thermal bridge in a similar manner to the structure and creates colder-than-ambient surfaces. The rink staff report that condensation has been observed dripping from the lights and cameras.

4. Consideration should be given to thermally separating indoor surfaces from outdoor temperatures. This is not an easy task for the structural members that bridge the insulation but suspended equipment such as lights and cameras can be suspended in such a way that cold is not transferred via metal chains.

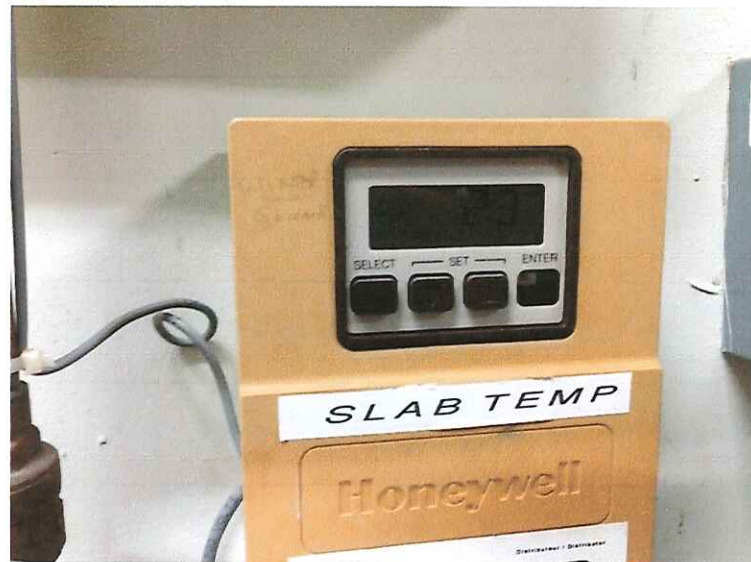
Figure 2-3: Refrigeration Controller

The curling rink ice surface is kept at approximately 23.5°F ice surface temperature, as this is optimal for curling. The slab is a concrete slab containing brine piping. The refrigeration plant is an ammonia plant with a single compressor and has no reported issues with keeping the ice surface temperature in the desired range. During times of excessive humidity, the ice can form surface frost which can cause the plant to run harder than it should. This leads to high energy bills.

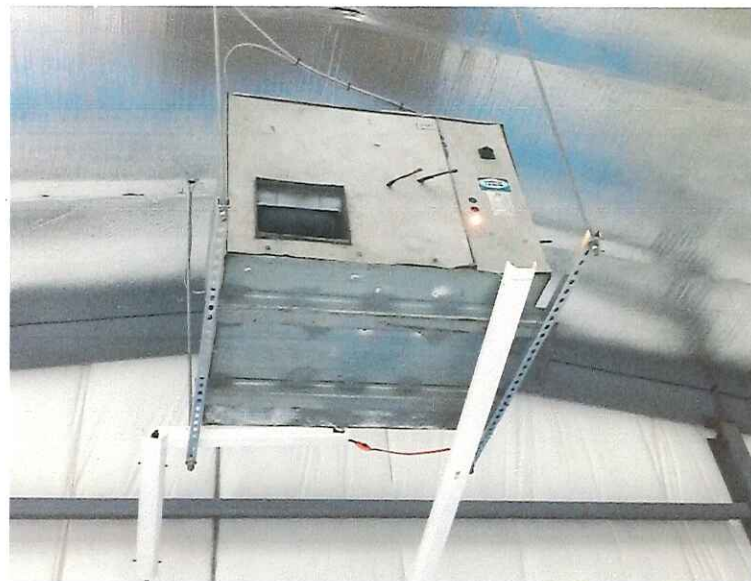
Figure 2-4: Dehumidifier

The rink has had more than one dehumidifier but generally the rink has only had a single dehumidifier in use at the far end of the rink. The unit is mounted high and the fan discharge is pointed toward the ice. There is no distribution ductwork attached to the unit. It was not

possible to access the unit at the time of the visit but the unit is a Cimco model currently loaned/donated by Cimco because the main unit has failed. The rink staff reports that the size is approximately 6 HP.

1. Since the existing dehumidifier has reached the end of its service life, our recommendation is to replace it with a desiccant dehumidifier such as the Cimco Desicon ET. This unit provides 2600 cfm of air and consideration should be given to adding distribution ductwork to give better air distribution throughout the length of the rink. Care must be taken when installing ductwork to avoid low points that could drip condensation on the ice (should it occur). Ductwork is commonly run above the walk platforms instead of the ice for this reason. Also, air distribution should be kept away from the ice surface since air movement at the ice surface can have an effect on ice quality.

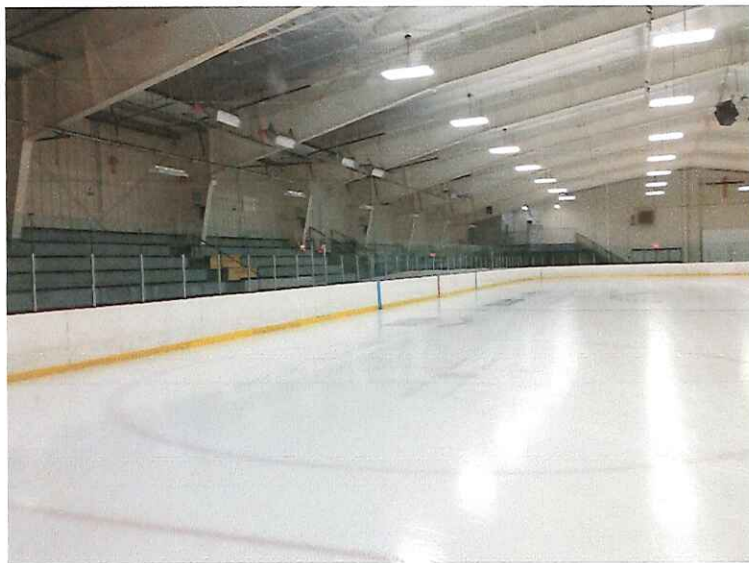
Figure 3-1: Hockey Rink

Both the arena and the curling rink are of similar construction. The hockey arena is a steel framed building with a sloped steel framed roof. The exterior siding is metal and the walls are insulated with batt insulation. The insulation is covered on the interior face using a plastic material which also serves as a vapour barrier. The roof is insulated in the same way as the walls. A reflective low-emissivity ceiling has been installed below the roof insulation. The building is built as a slab-on-grade with a concrete foundation that does not extend much above grade.

The rink has no exterior windows. The exterior doors consist of a single overhead door to the ice resurfacing equipment (Zamboni) room and several fire exit man doors, which are typically closed. There are exit doors to the outdoors but these are kept closed. The doors appear to be adequately sealed against unwanted infiltration of outdoor air.

The metal structure extends through the insulation on both the walls and the roof. This creates a thermal bridge conducting heat (and cold) to and from the outside via the metal structure. When it is colder outside than in the rink, this creates a colder-than-ambient surface where water is more likely to condense. Rink staff report that condensation has been observed dripping from the structure. Drip pans and drainage piping have been installed to deal with this issue.

Lights are suspended on metal chains and the chains are connected to the metal structure. The metal chain acts as a thermal bridge in a similar manner to the structure and creates colder-than-ambient surfaces. The rink staff report that condensation has been observed dripping from the lights.

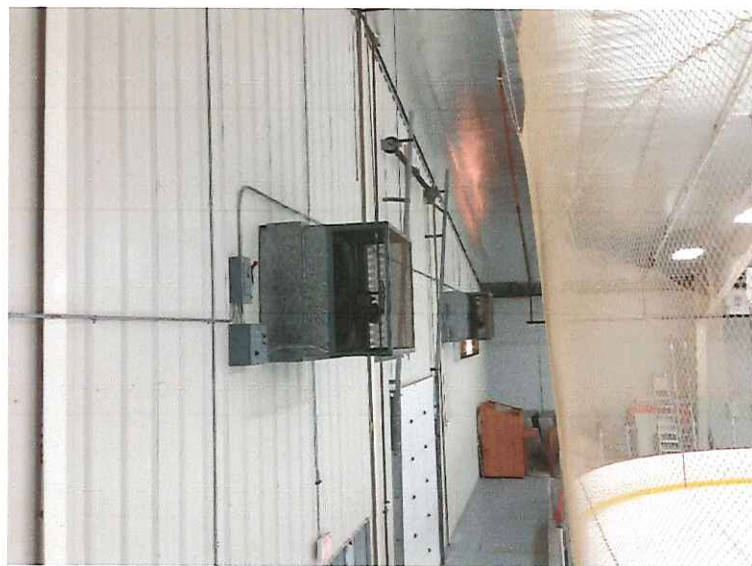
Figure 3-3: Ventilation Fans

The rink has two large propeller exhaust fans mounted high at one end of the rink. There are intake louvers mounted high at the opposite end of the rink. These are typically kept turned off and closed except when CO levels rise above the set point. The CO is generated by the ice resurfacing equipment and the ventilation is required for air quality reasons.

The ventilation system must be able to operate in order to keep adequate indoor air quality. Some rinks temper the outdoor air but for an arena of this type, this is rare.

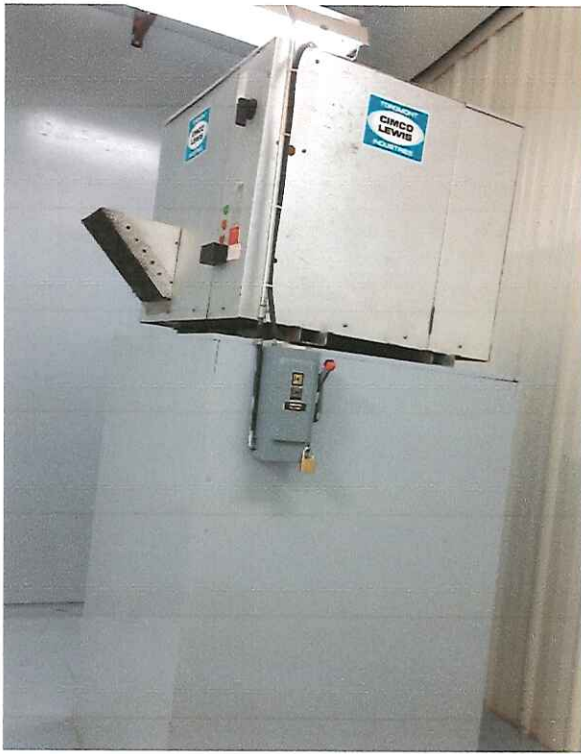
Figure 3-4: Dehumidifier #1

The arena has two Cimco model MK-VII dehumidifiers installed on service platforms in the corners of the rink. The dehumidifiers were both running during the site visit.

Our recommendation to help reduce humidity levels in the fall shoulder months would be to add dehumidification capacity in the form of a third refrigeration based dehumidifier. This could be located on the platform closest to the arena entrance, although this would be at the expense of some seating.
