STAFF REPORT

SUBJECT: Arena Fees

MUNICIPALITY OF THE DISTRICT OF BARRINGTON INFRASTRUCTURE ASSESSMENT AND RECOMMENDATIONS

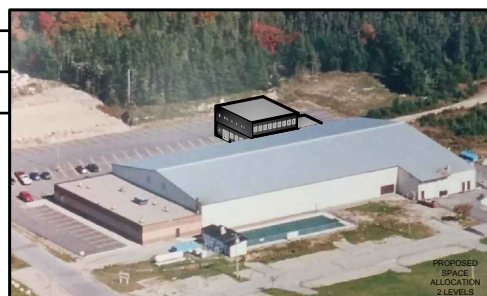
DRAWING TITLE:			
PROPOSED SPACE ALLOCATION 2 LEVELS			
DWN BY:	D.M.	CKD BY:	J.M.
DES BY:	J.M.	SHT NO:	5 of 7
SCALE:	NTS		
CLIENT JOB NO:	MoDB1701		EASTPOINT JOB NO:
			309001
DRAWING NO:	ASK-005		REV:

PROPOSED SPACE ALLOCATION 2 LEVELS
